Preliminary Site Investigation

Smithfield Battery Energy Storage System, 6 Herbert Place, Smithfield, NSW, 2164

30 October 2023

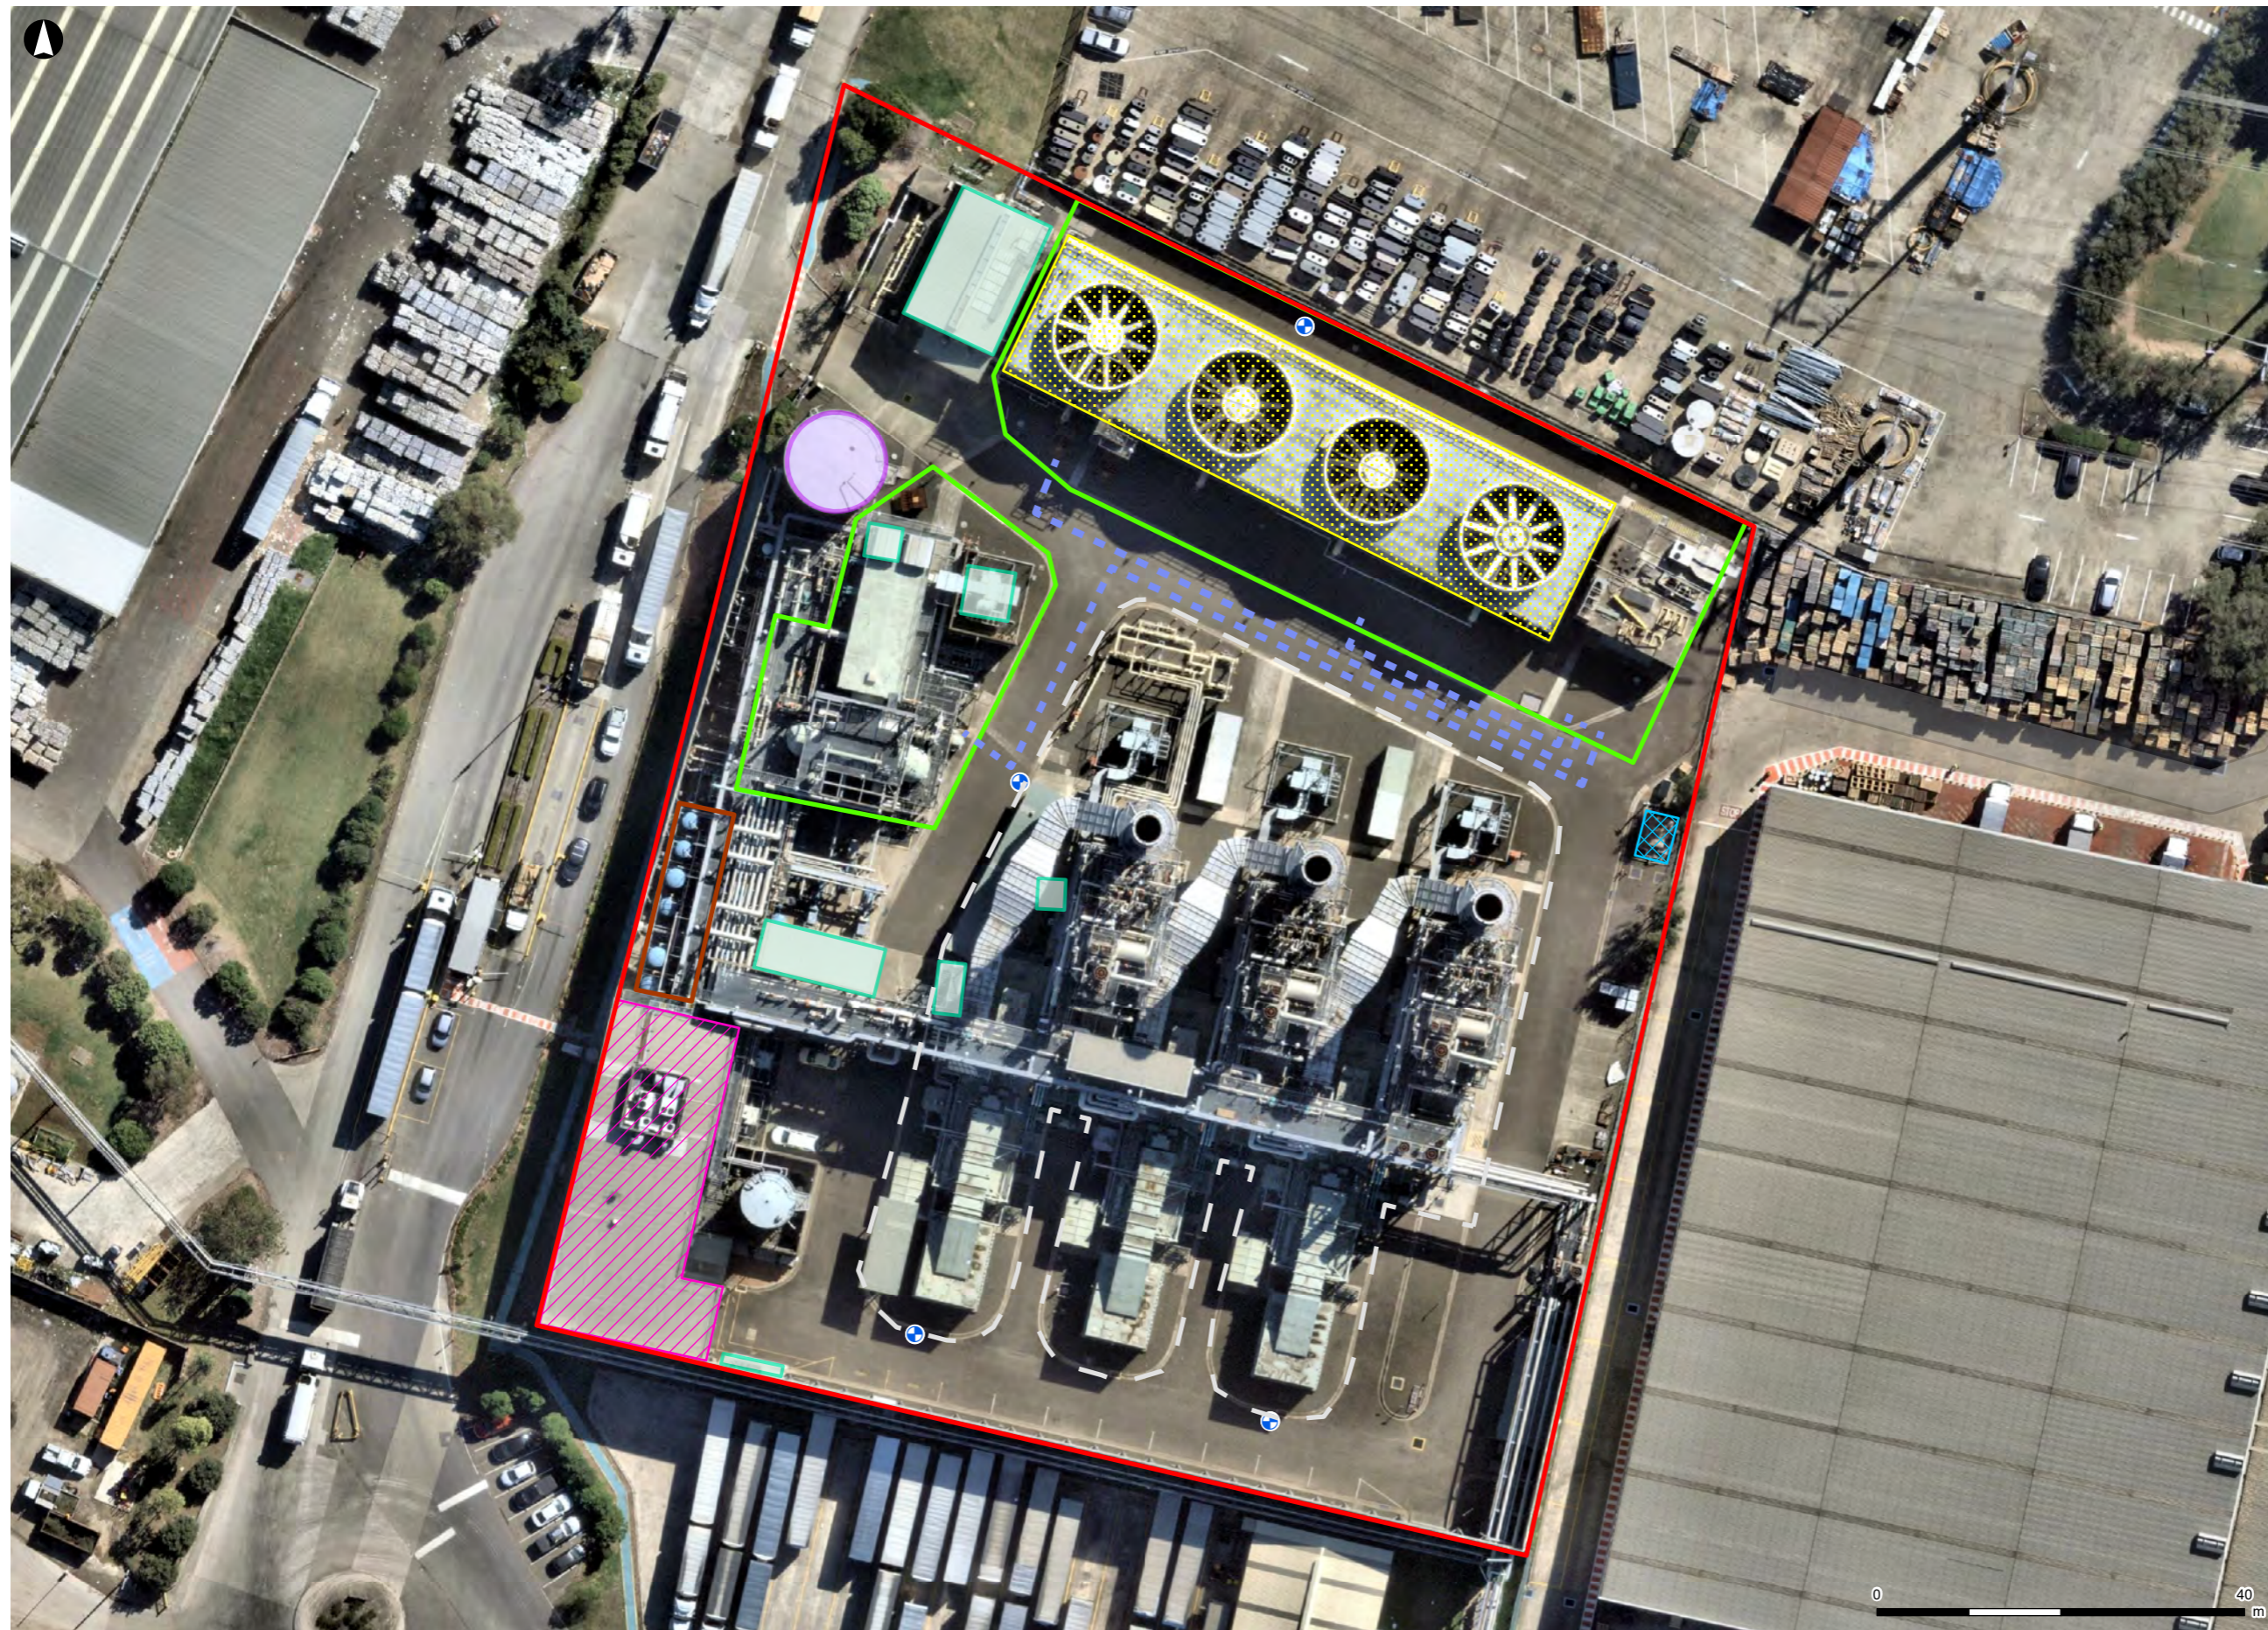
Figure 2 – Site Layout

- LEGEND**
- ▭ Approximate Site Boundary
 - ▭ Approximate BESS Area
 - ▨ Site Office
 - ▨ Cooling Towers
 - ▭ Chemical Storage Areas
 - ▭ Anion Exchange and Water Dosing Tanks
 - ▭ Water Tank
 - ▭ Oil-Water Separator
 - ▭ Gas Turbine Generator Facility
 - MV Cable
 - Wells
